# Kittson Parkway / Watershed Park Parking Lot

# Holly Park Parking Lot and Rain Garden

## 55B Street BMP

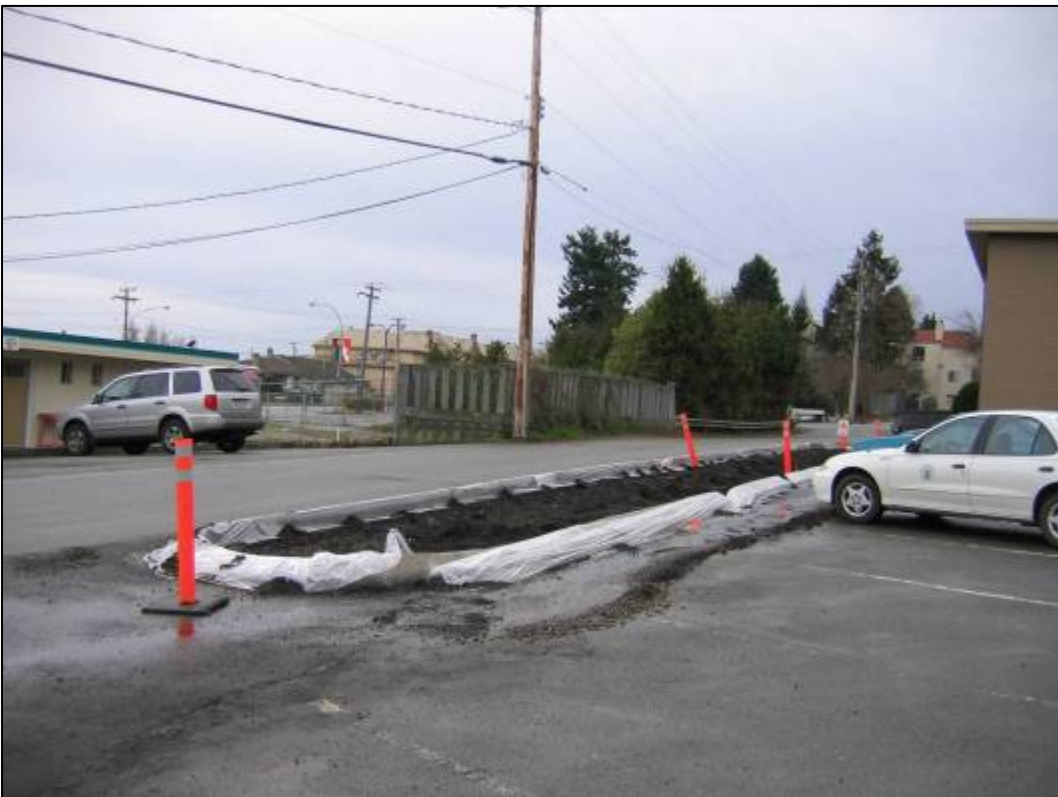
- Not constructed as designed due to miscommunication; the idea was for the water to run into the planter and infiltrate; not much water enters the planter as constructed because the soil in the planter was accidentally mounded for planting; asphalt diverters were installed in an attempt to mitigate this problem

After construction (January 2006)

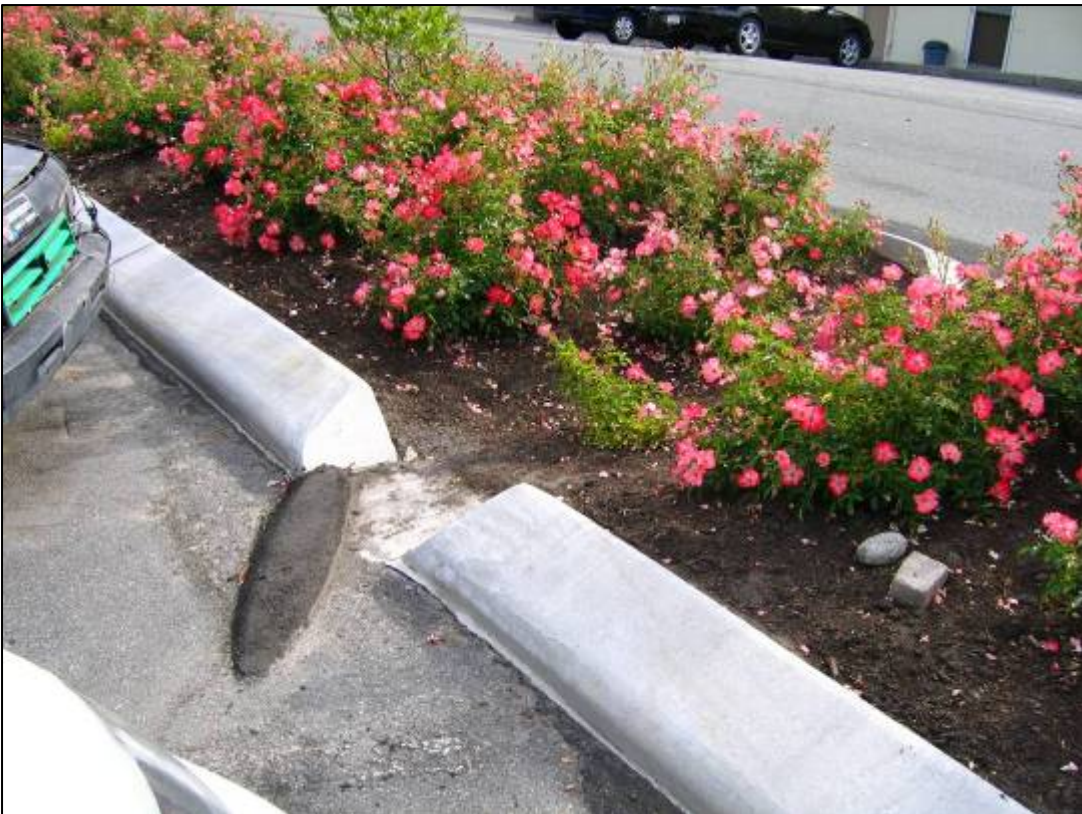
Asphalt diverter for directing drainage into planter

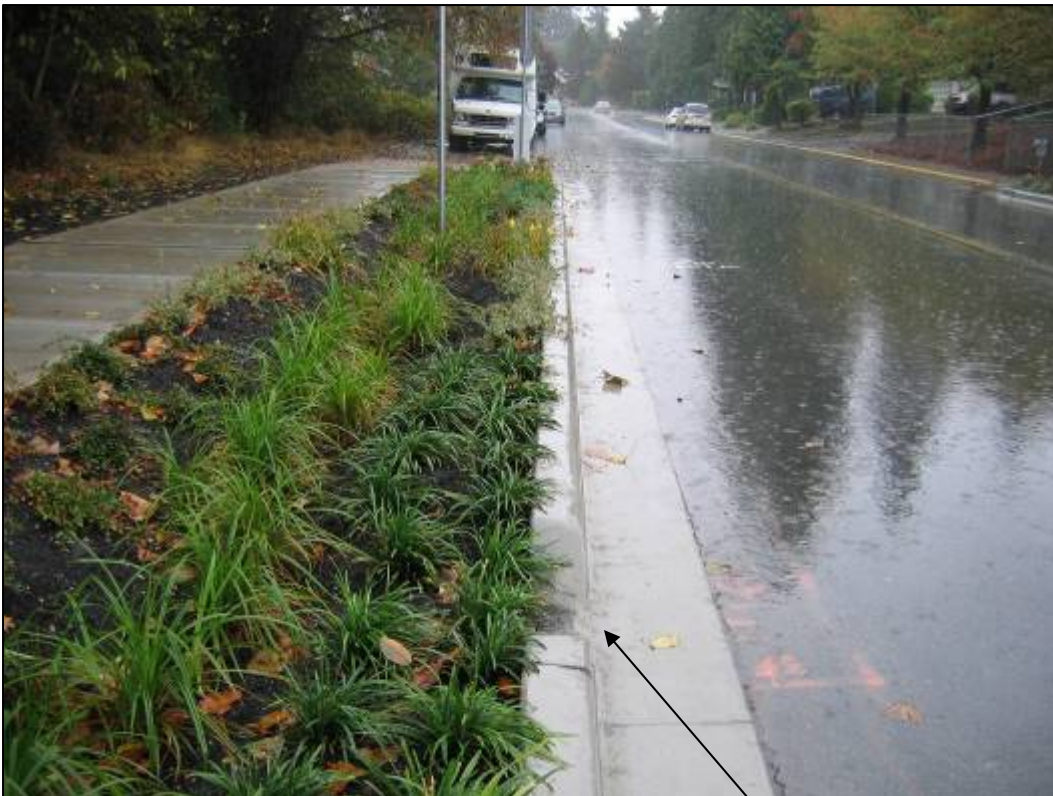
North side during heavy rainfall event (September 2005); runoff entering from the curb cut was absorbed by the drain rock within 50cm of entering the swale

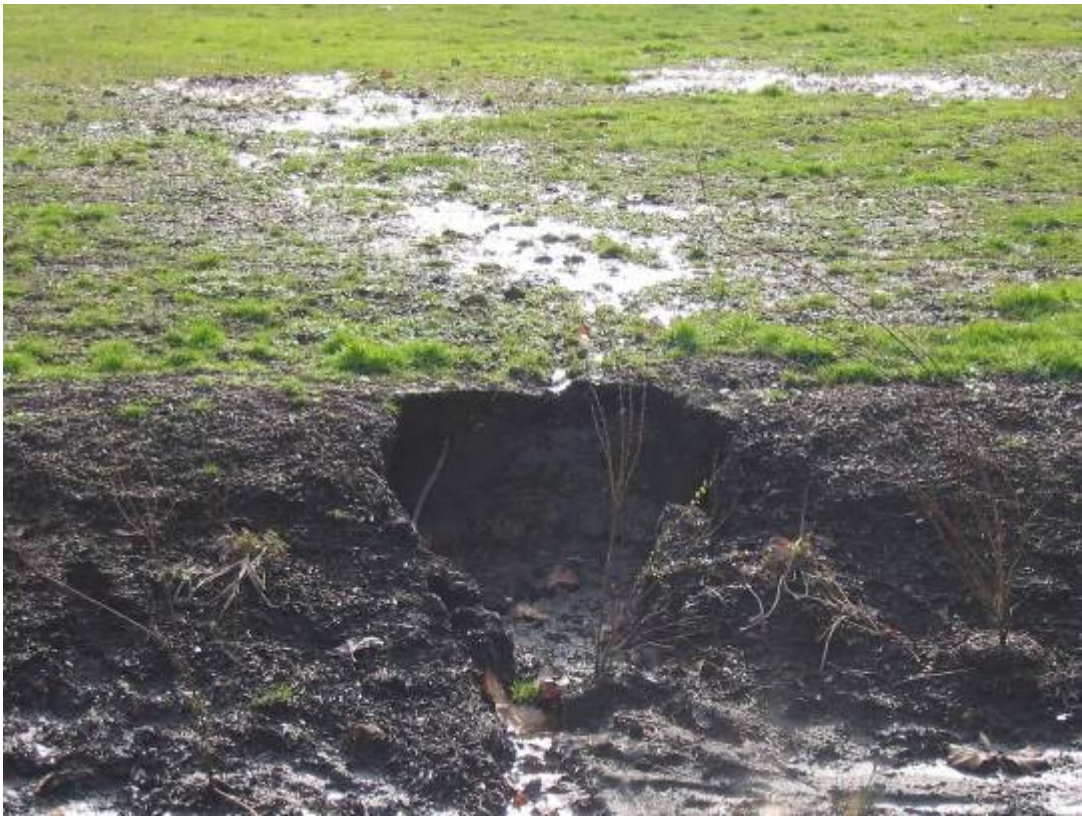
Erosion after unusually wet winter (February 2005)

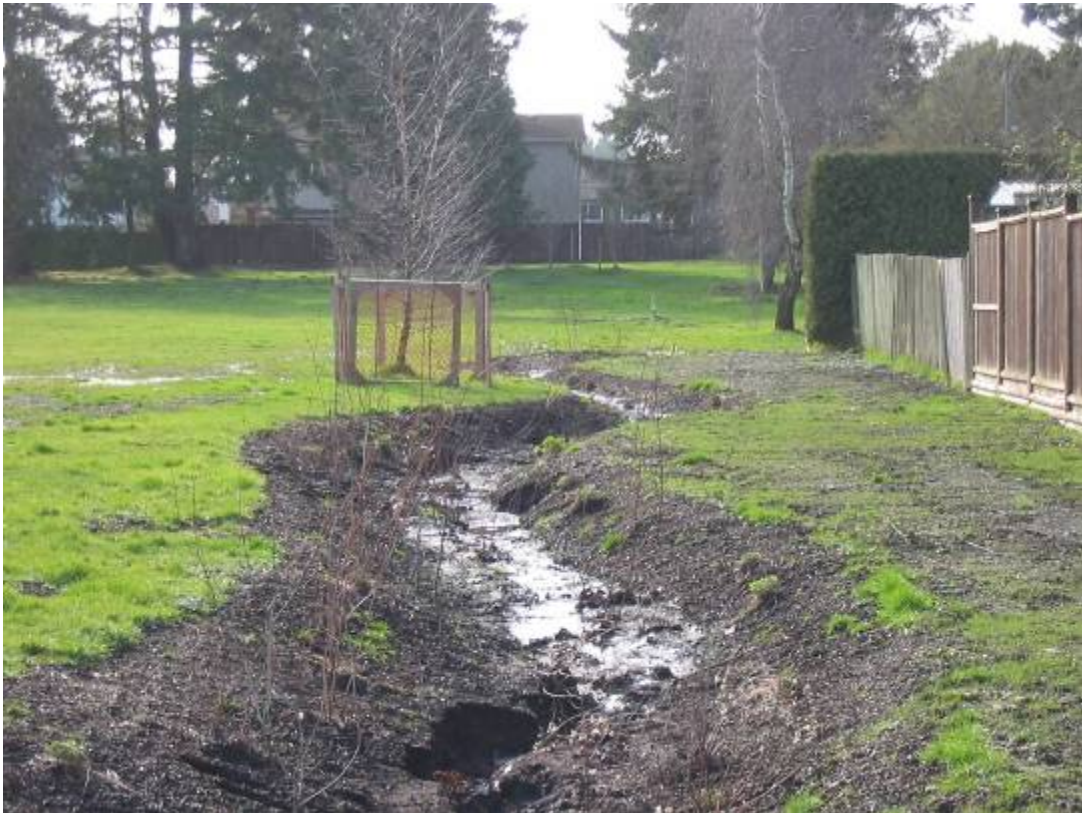
Erosion after unusually wet winter (February 2005)

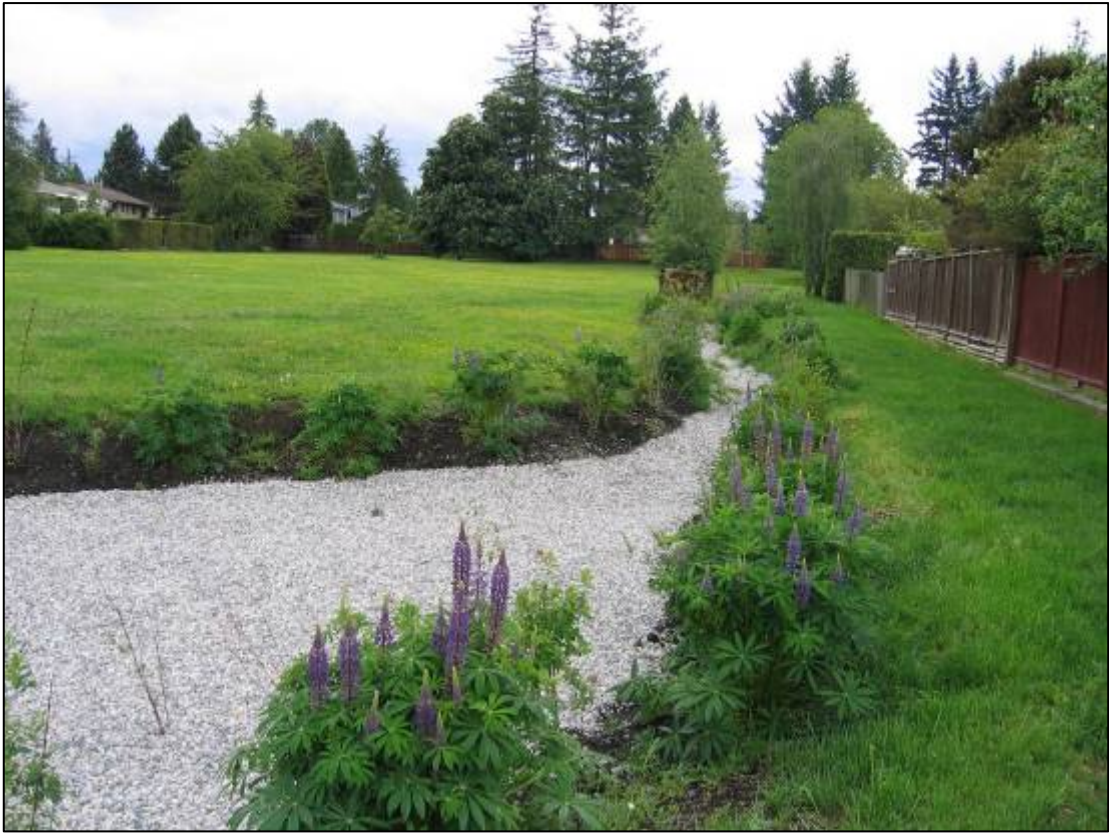
Placement of rock in swale to prevent erosion and standing water (July 2006)

- Project was successful in reducing flooding to adjacent properties; it turned out that the winter water table was higher than our overflow drain and there was standing water until early summer; we fixed this problem by adding drain rock

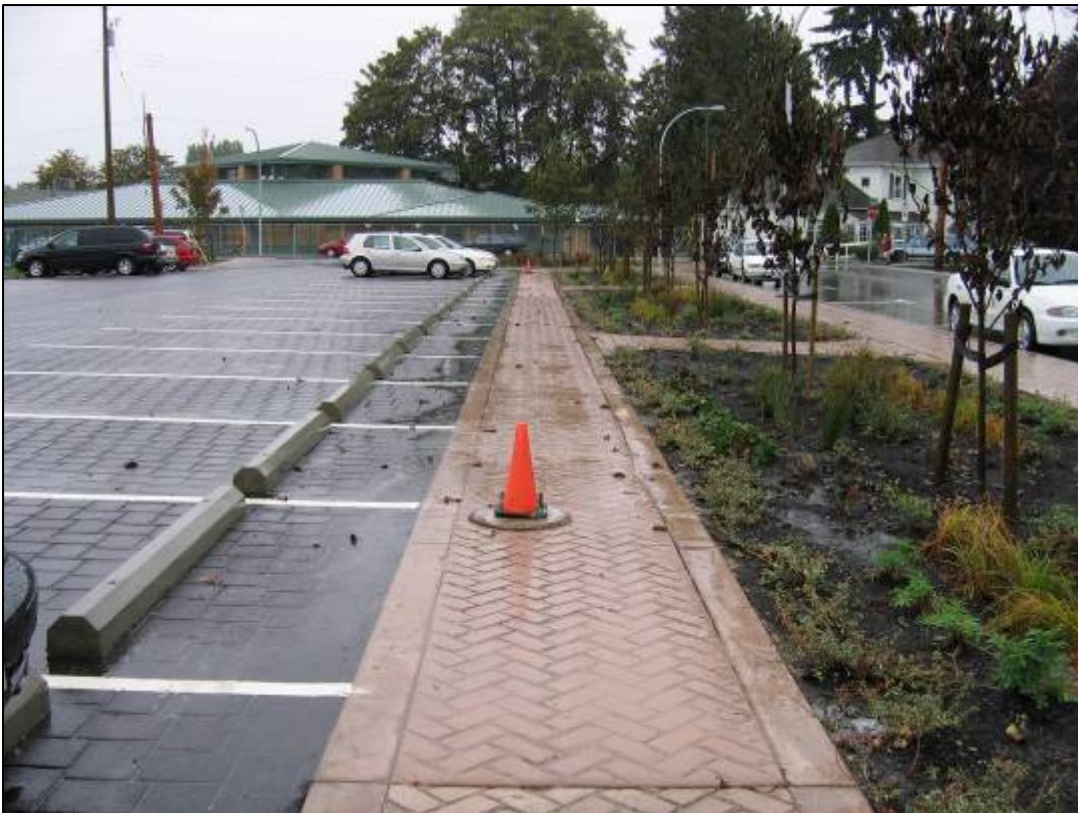
- Summer Maintenance: Some plants are perennials, which require a higher level of maintenance
- Winter Maintenance: Grade change between asphalt parking surface and concrete walkway resulted in a minor depression between the two areas; this depression will require salting on cold days to ensure pedestrian safety

Completed project after heavy rainfall event; note pooling of water between asphalt parking lot and concrete walkway, and within the planting area

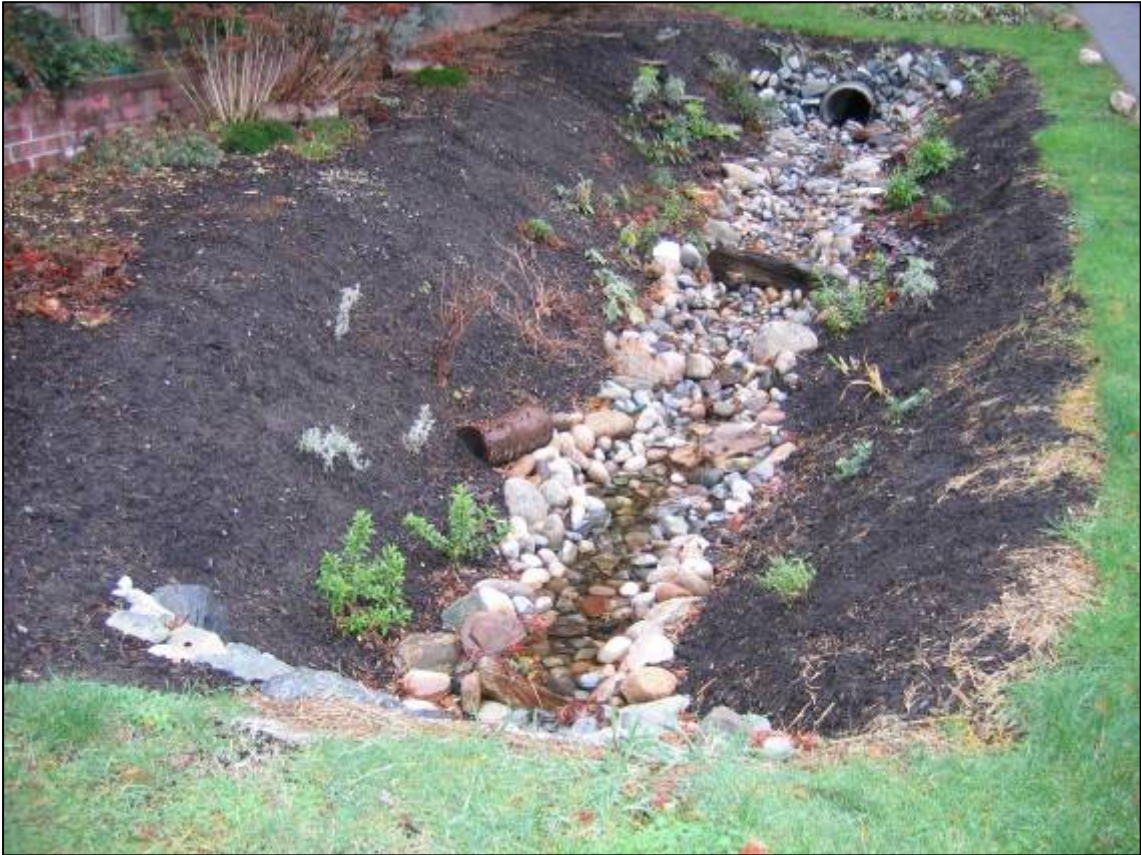
During heavy rainfall event (November 2006)

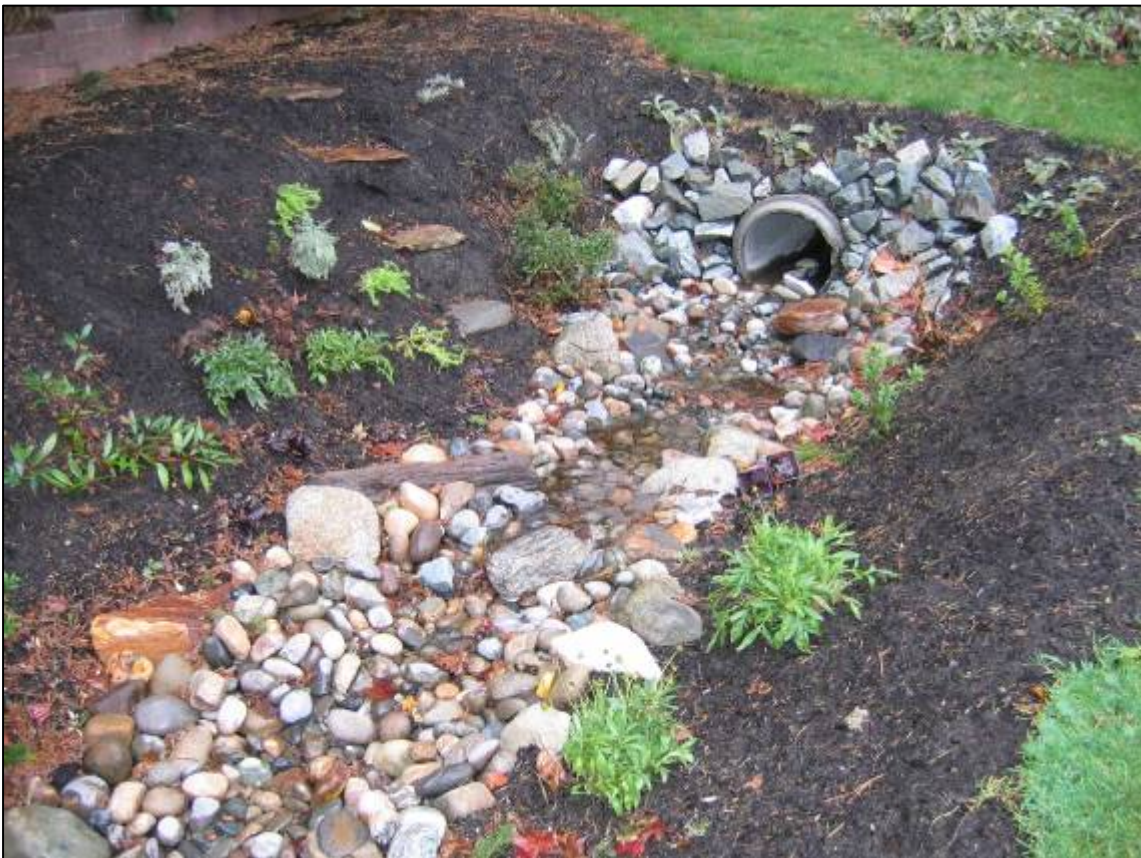
During heavy rainfall event (November 2006)
