# Kittson Parkway / Watershed Park Parking Lot

# Holly Park Parking Lot and Rain Garden

## 55B Street BMP

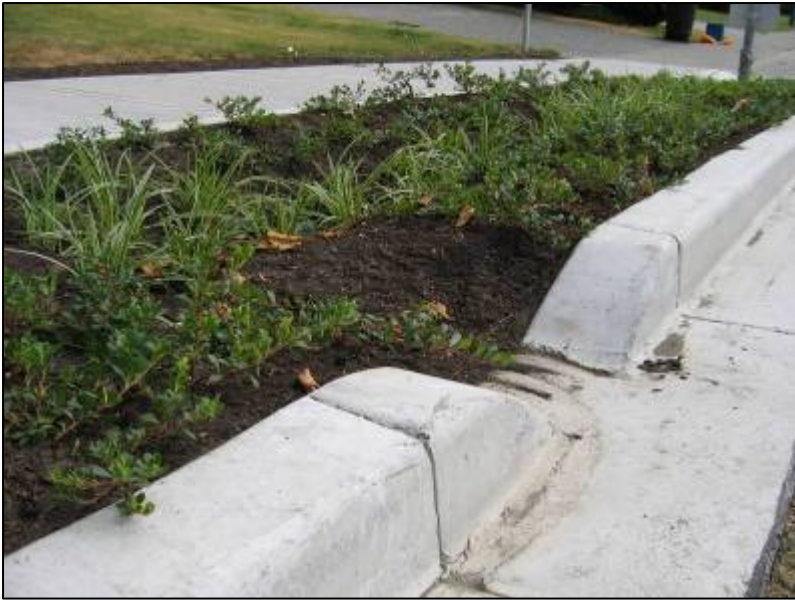
- Contractor education: Landscape contractor was not properly educated as to the BMP function of this site. Although contract drawing indicates swale, excess mulch was placed in the BMP causing water to leave instead of enter the planting area through the curb cut. This soil grading deficiency was repaired.

After planting; shows excess soil and incorrect grading

- More grading work required to properly divert water from street into BMP
- Plants are very healthy; nearby resident might be watering the garden

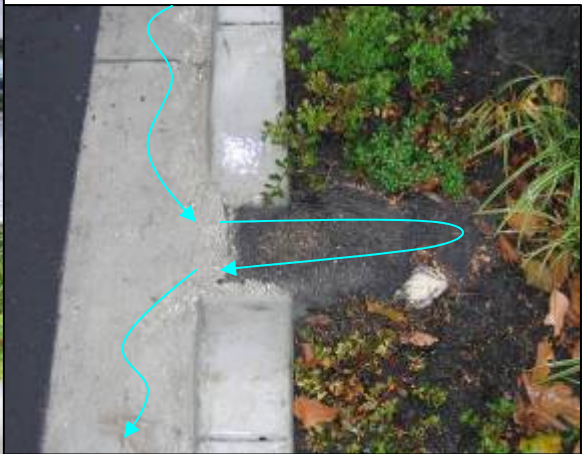
BMP during heavy rainfall event; water not absorbed as desired due to high soil levels in planted area

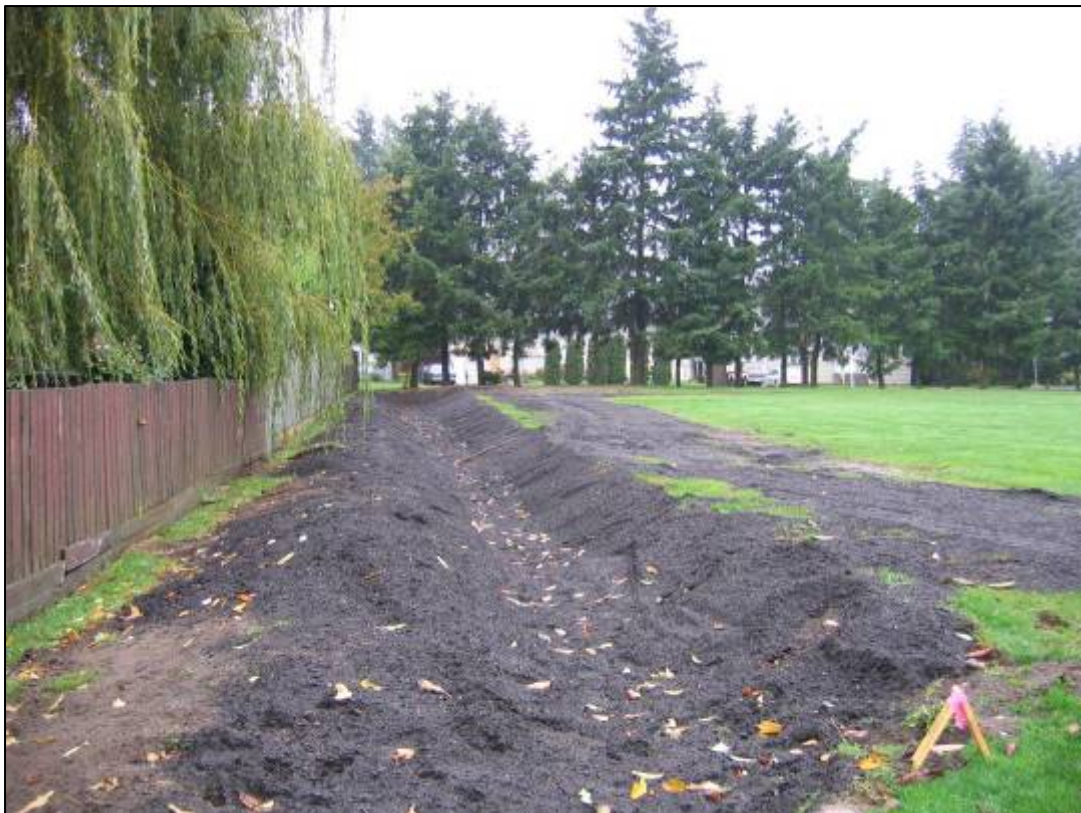
Completed swale with berm on fence side (October 2005)

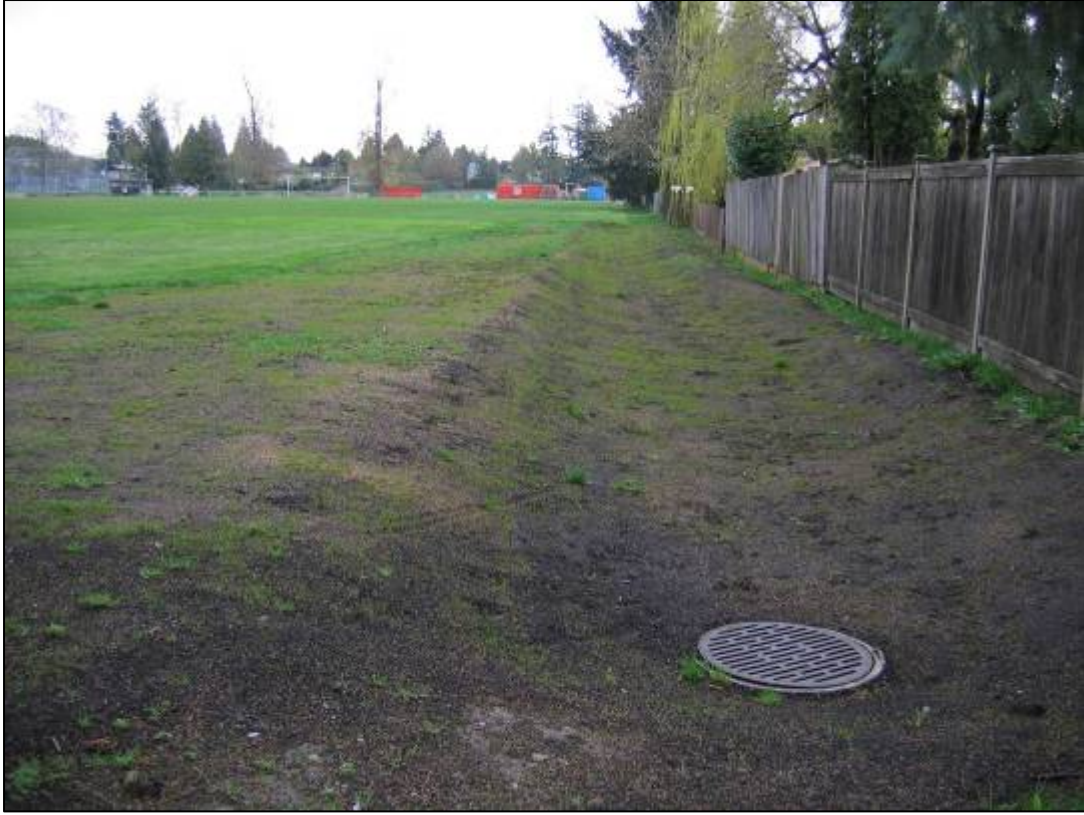
Swale after re-grading to make shallower for sports field users; planted with grass  
(April 2006)

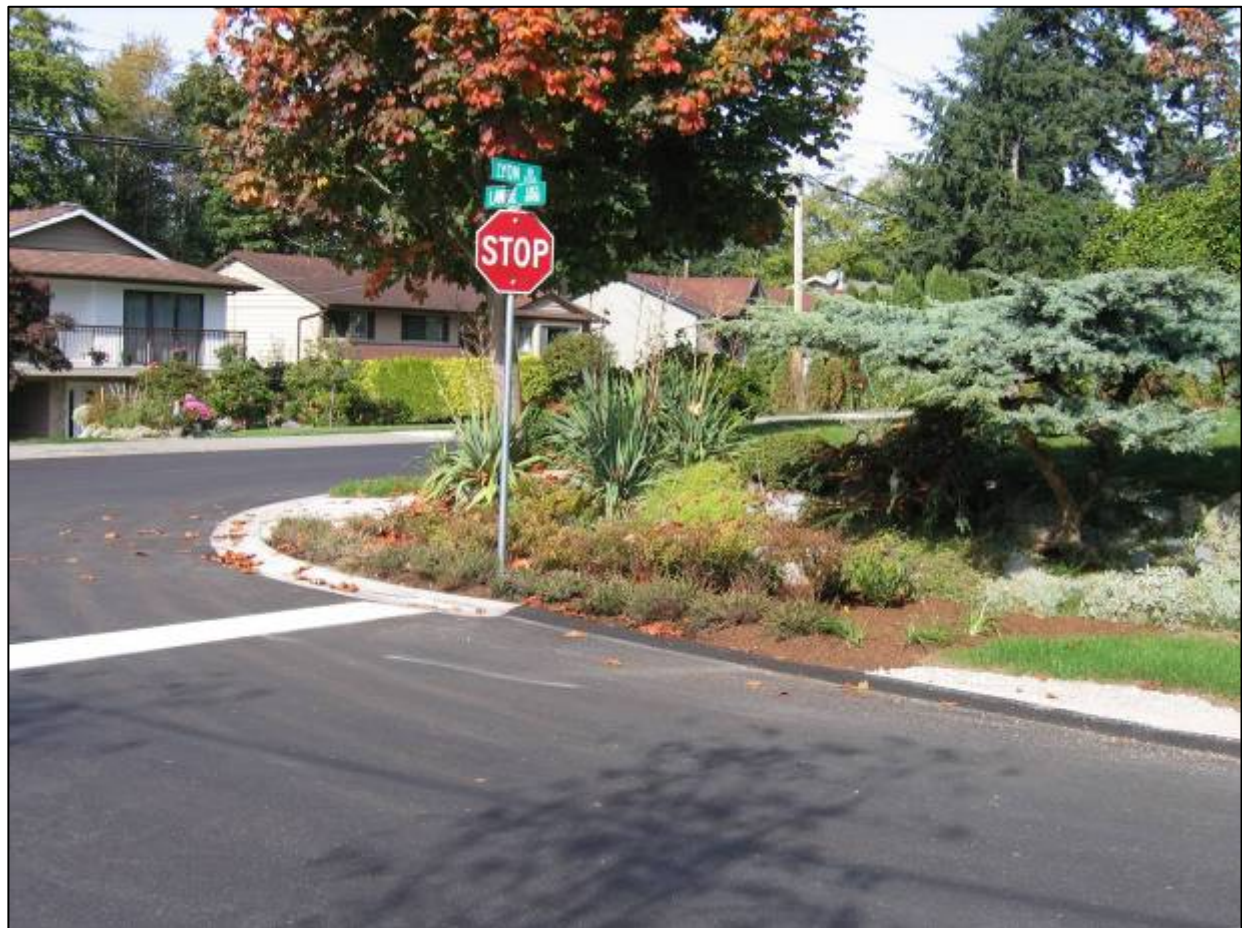
After construction (October 2006). Grass swale drains to rain garden. Overflow drain is behind the stop sign. Existing garden behind construction area was retained.

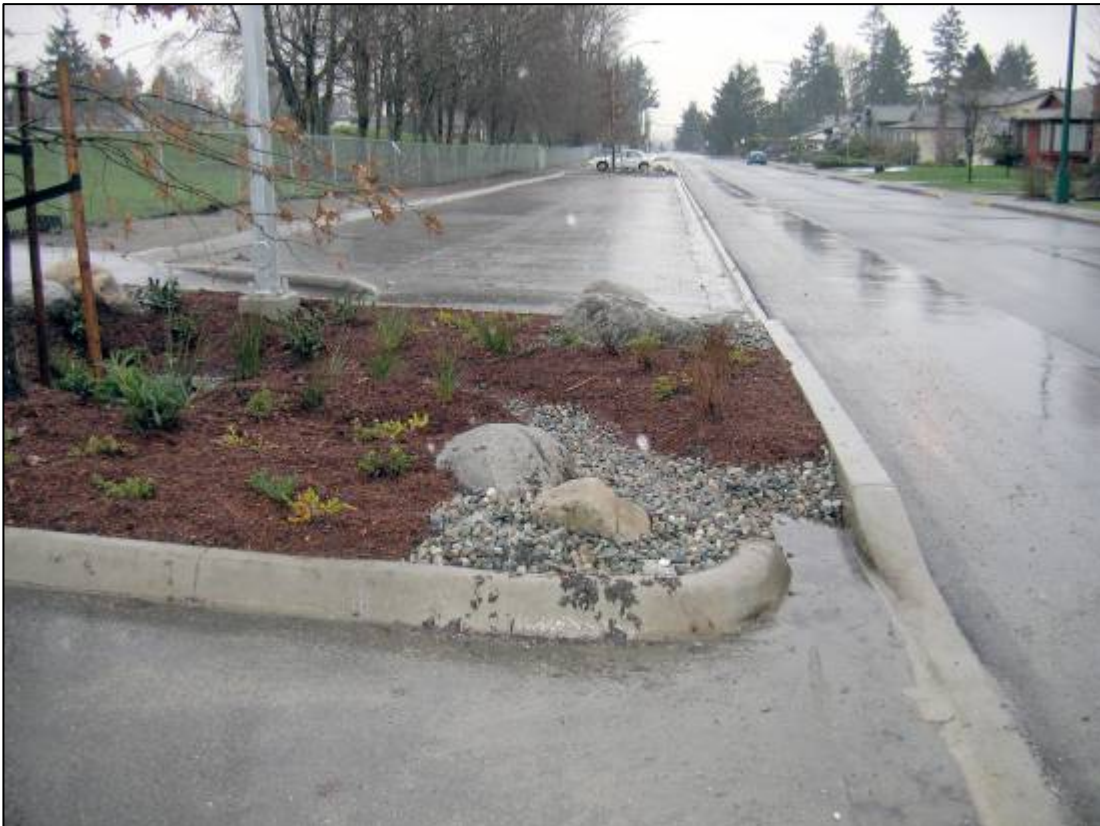
After construction (January 2007). Rain gardens collect and infiltrate water from paved parking areas.

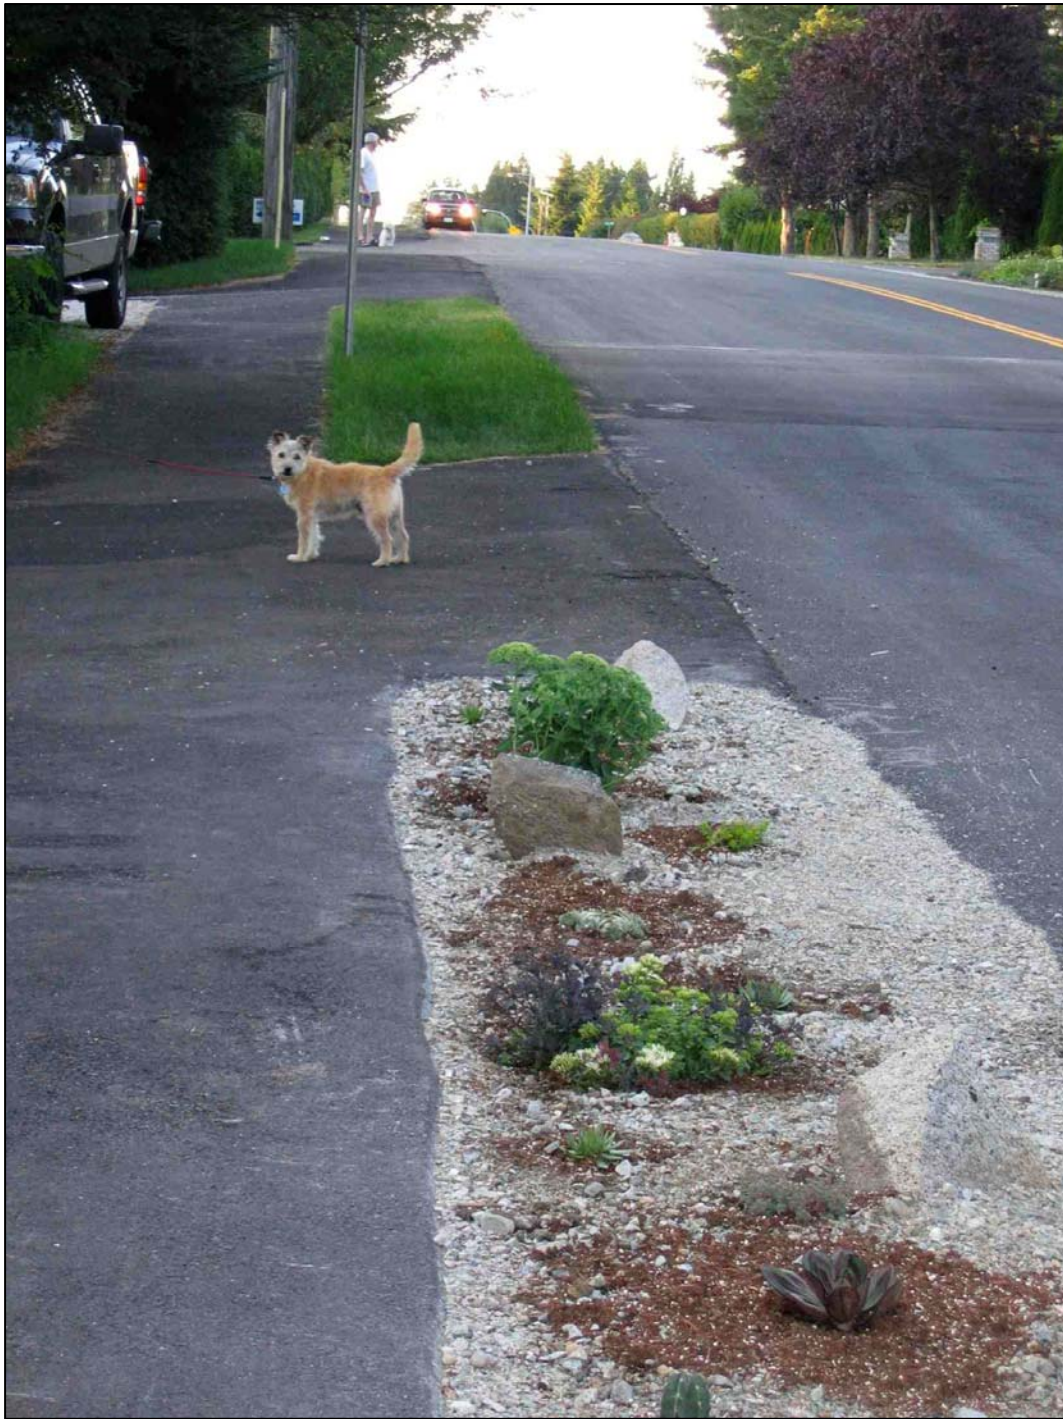
At-grade asphalt sidewalk; typical grass swale in background and resident's landscaping additions in foreground

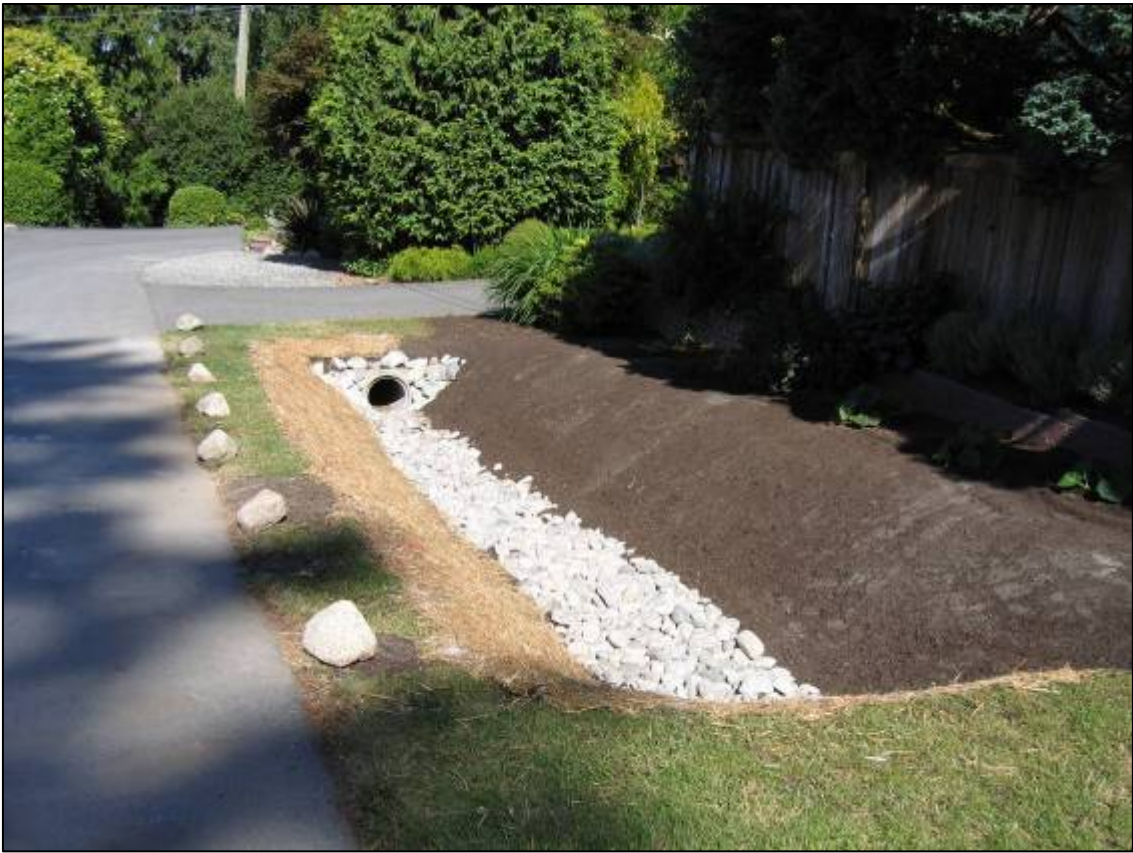
Construction complete (June 2006); temporary mesh installed on road side of ditch to minimize erosion until plants are installed
