# Kittson Parkway / Watershed Park Parking Lot

# Holly Park Parking Lot and Rain Garden

## 55B Street BMP

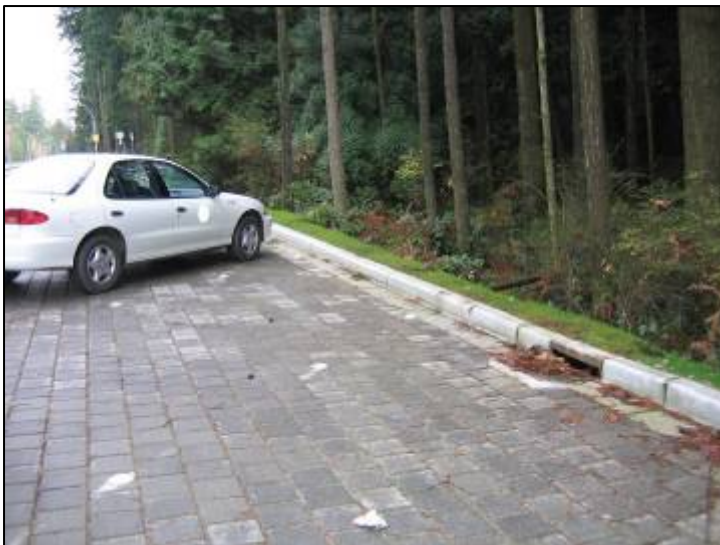
Overflow drainage

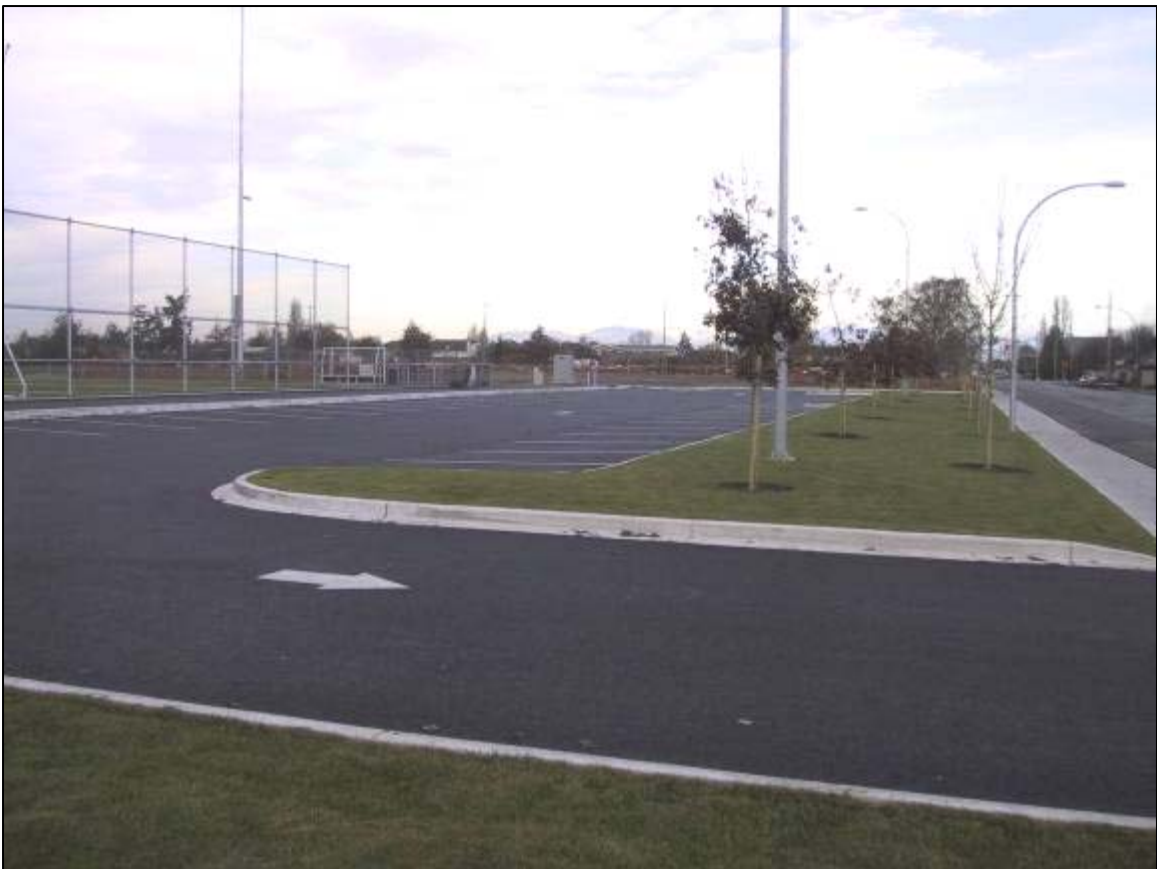
- Permeable asphalt is working; paved surface remains free of water during heavy rainfall events
- Drainage system works well; rain garden has standing water throughout the wet season

Permeable asphalt parking lot

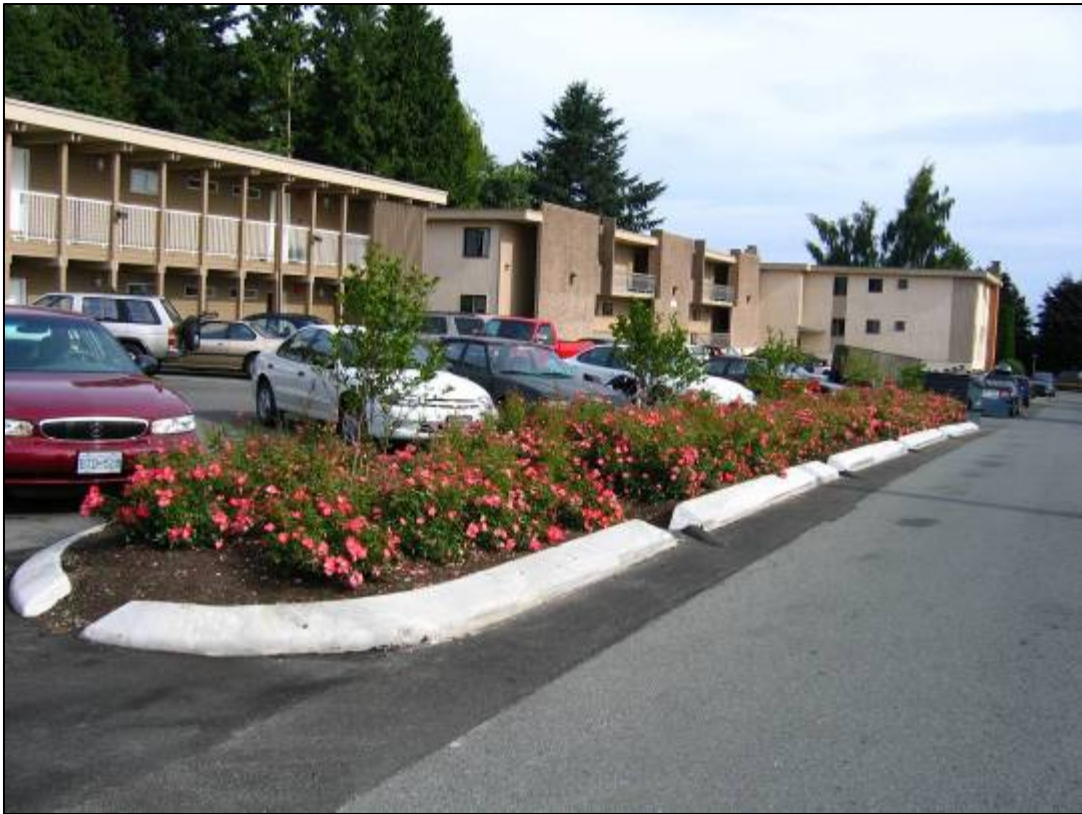
- Not constructed as designed due to miscommunication; the idea was for the water to run into the planter and infiltrate; not much water enters the planter as constructed because the soil in the planter was accidentally mounded for planting; asphalt diverters were installed in an attempt to mitigate this problem

After planting (July 2006)

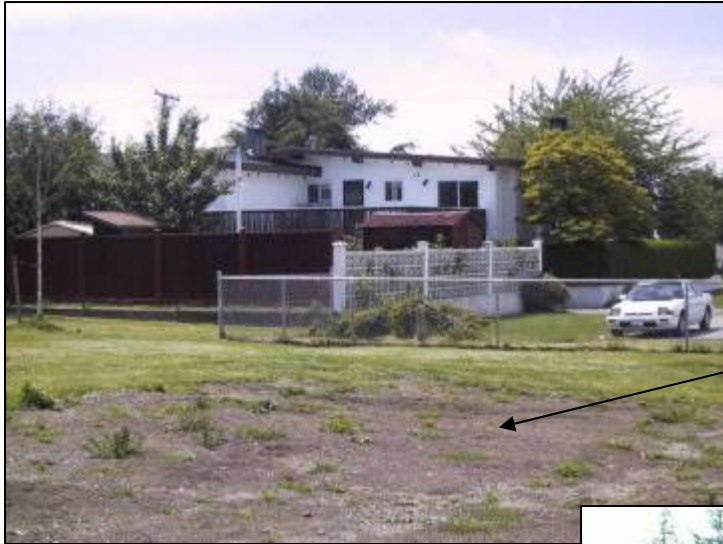
Note grass damaged by annual winter flooding

Prior to construction (summer 2004)

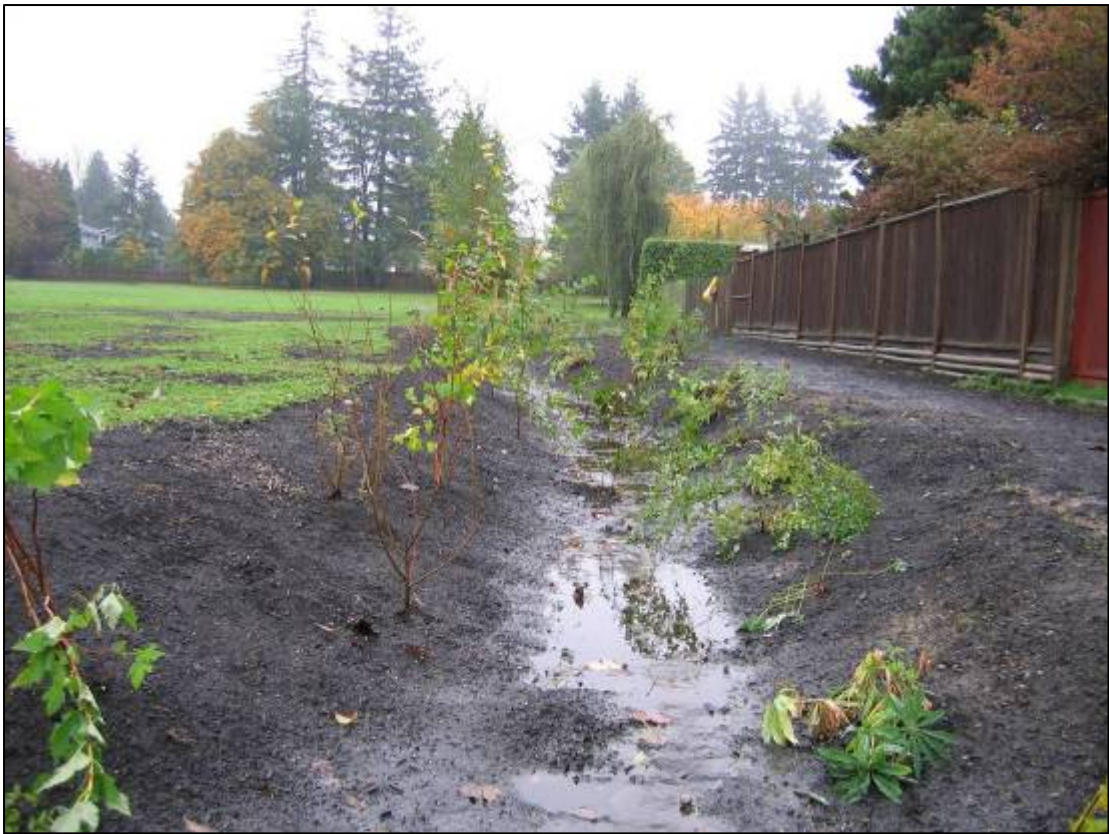
- Project was successful in reducing flooding to adjacent properties; it turned out that the winter water table was higher than our overflow drain and there was standing water until early summer; we fixed this problem by adding drain rock

Swale in action (October 2005)

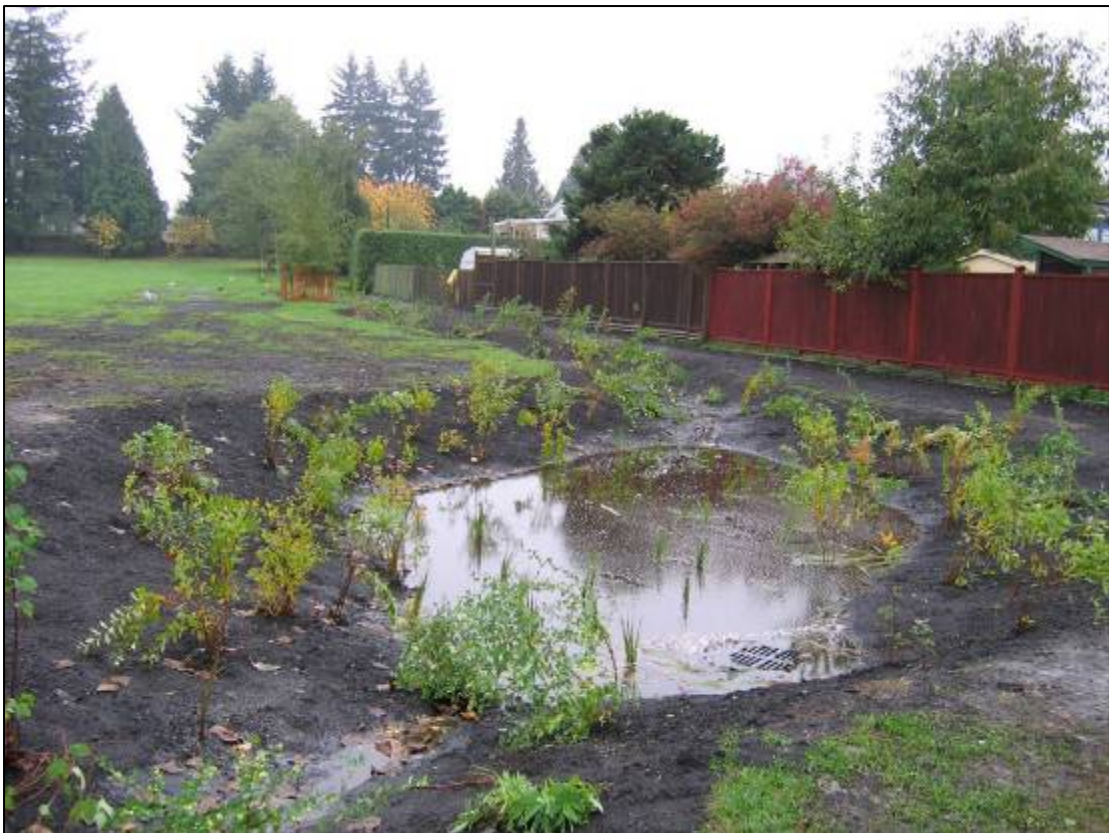
Swales flowing into rain garden pond (October 2005)

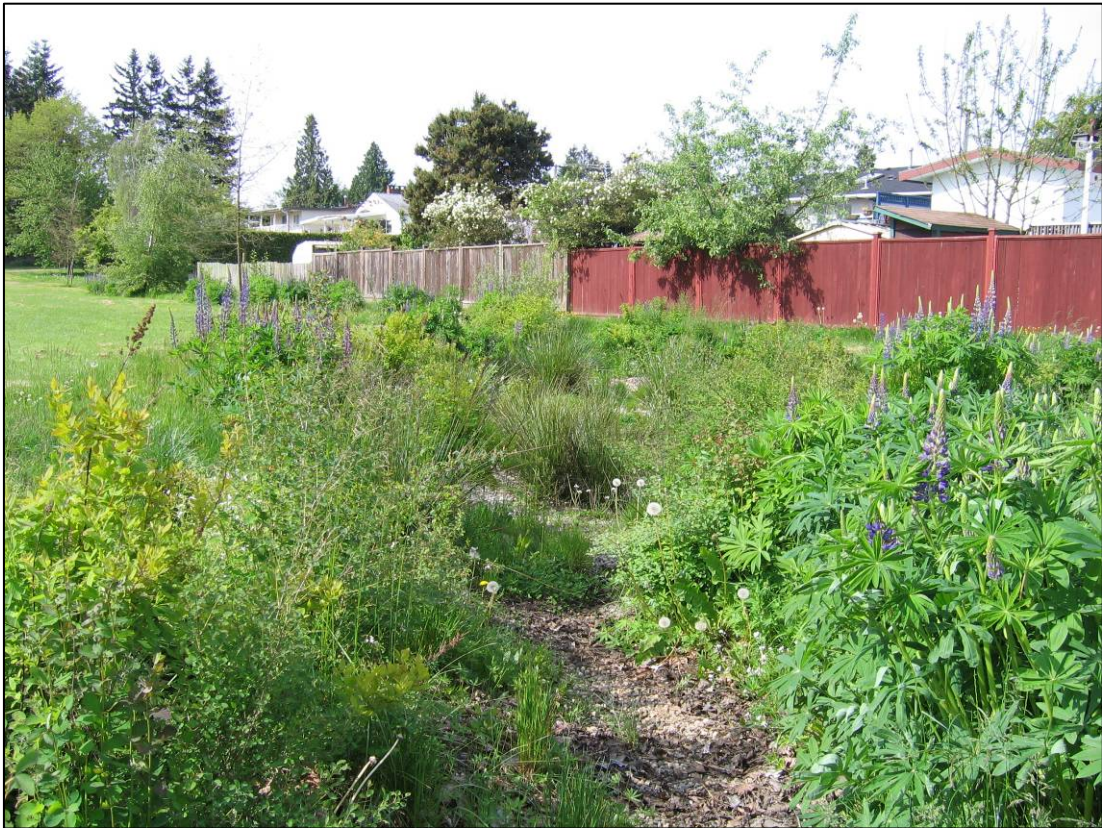
Swale and pond filled with native vegetation (May 2007)

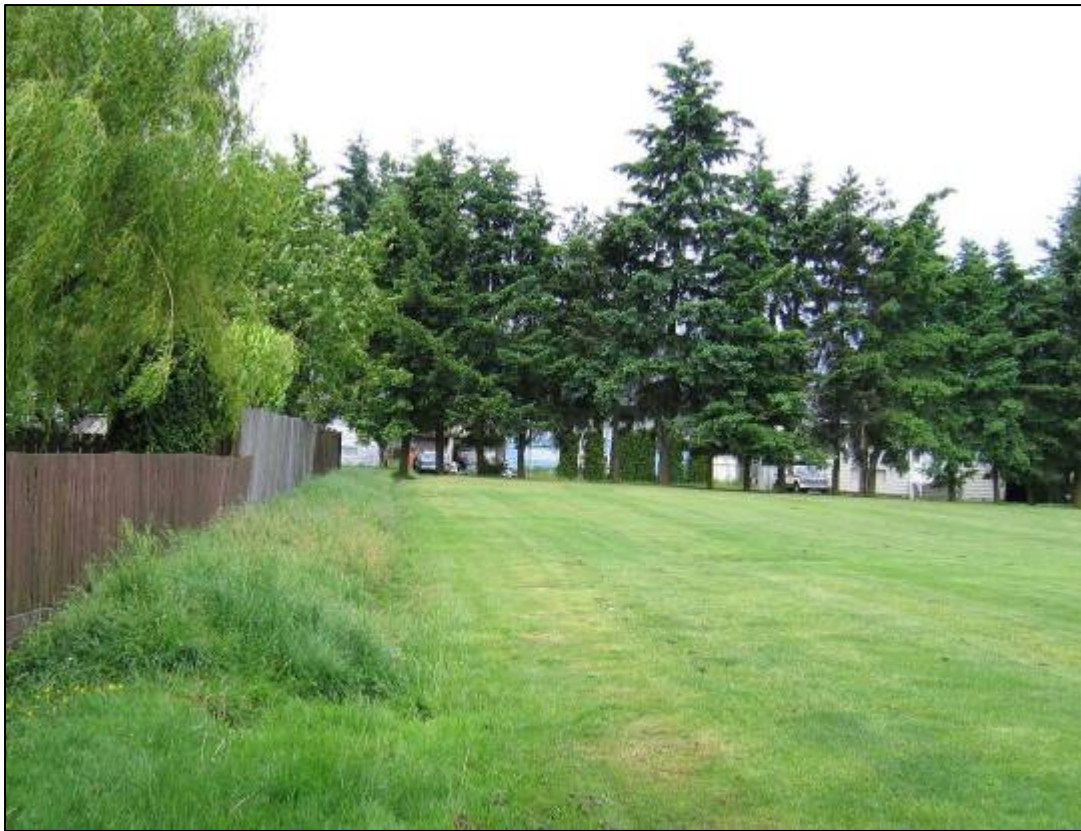
Temporary trench (hidden by overgrown grass) (summer 2005)
